D-Learning Class for Earthquake and Tsunami Disaster Mitigation
November 10, 2017

Seismic Performance of Masonry Buildings in Turkey

Prof. Murat Altuğ Erberik

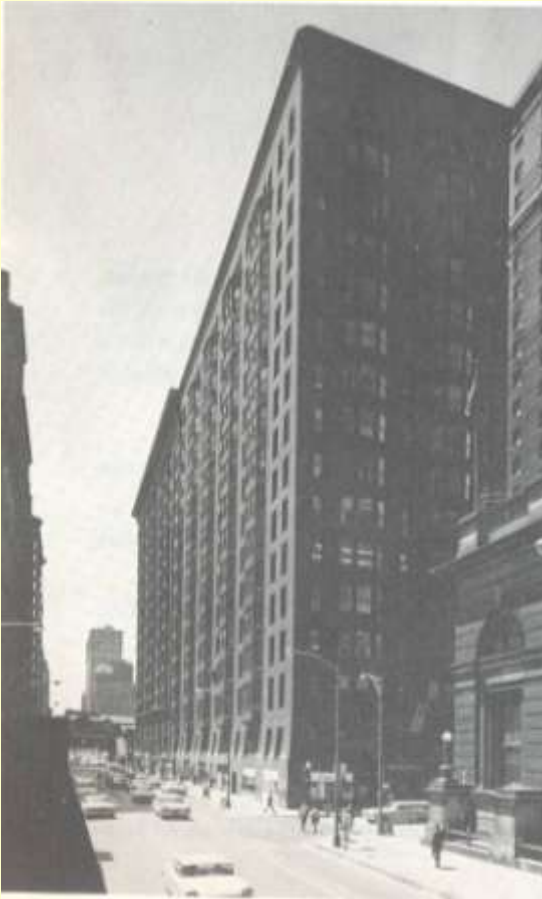
Unreinforced Masonry Building Example

- ✚ 16-story Monadnock Building in Chicago, USA.
- ✚ A brick bearing wall structure built in 1889-1891.
- ✚ **Thickness** of unreinforced masonry walls at the base is **1.8 m**.

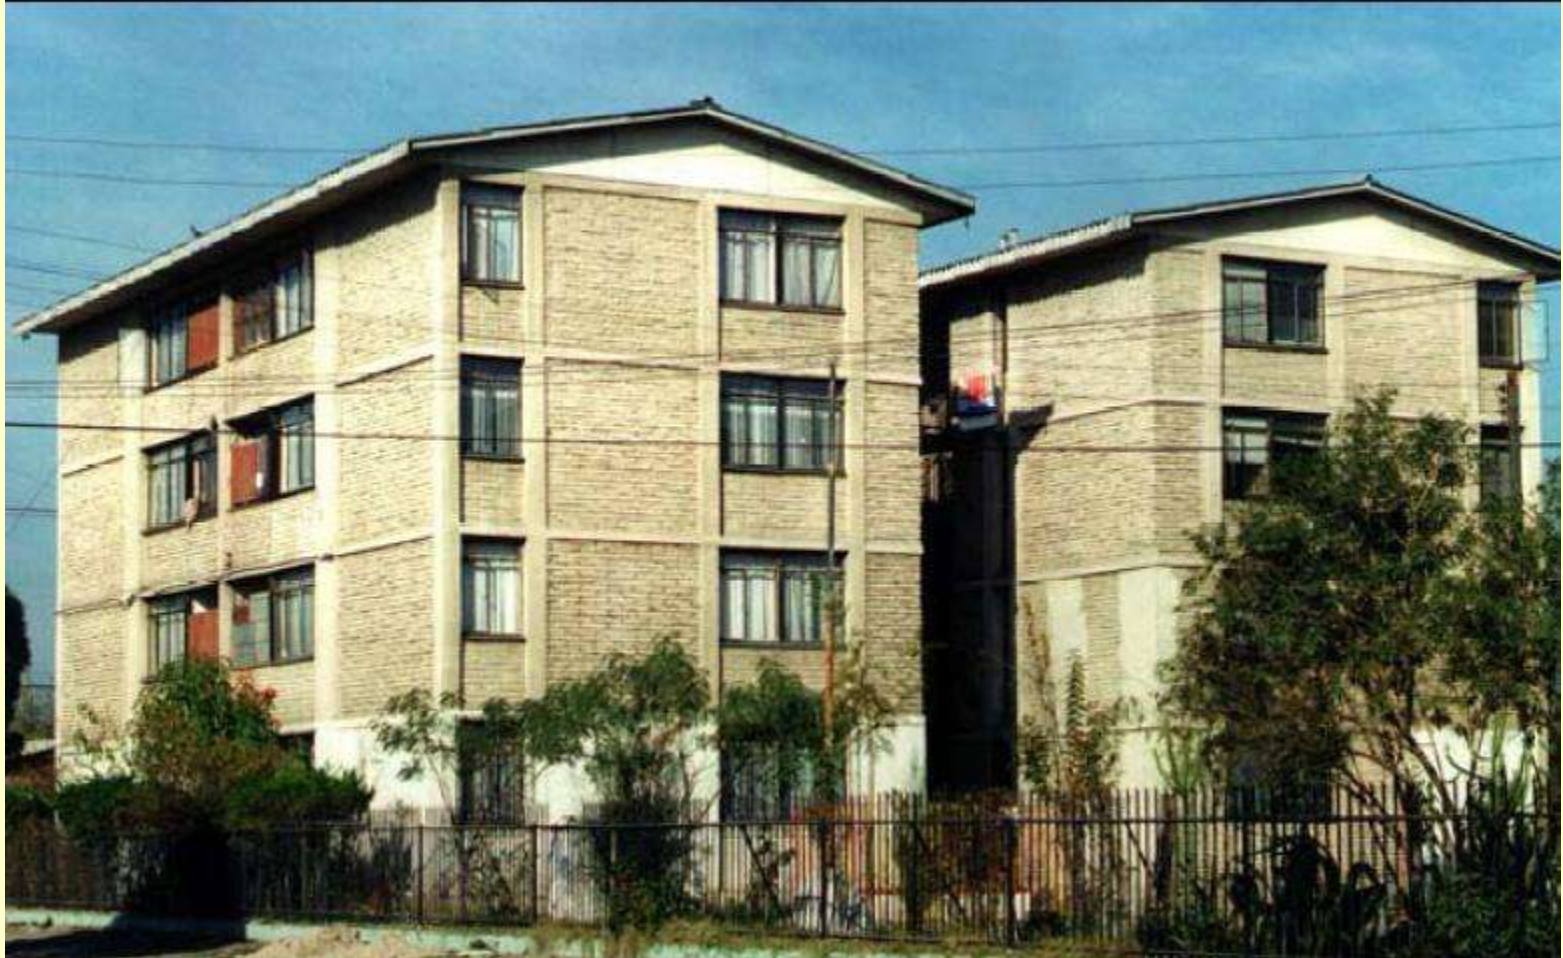
Confined Masonry

Confined masonry construction consists of unreinforced masonry walls confined with reinforced concrete (RC) tie-columns and RC tie-beams.

The tie-columns and tie-beams provide confinement in the plane of the walls and also reduce out-of-plane bending effects in the walls.

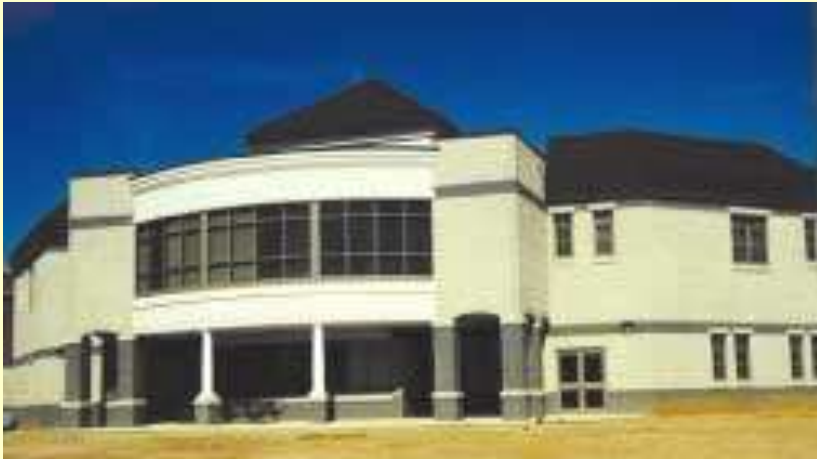
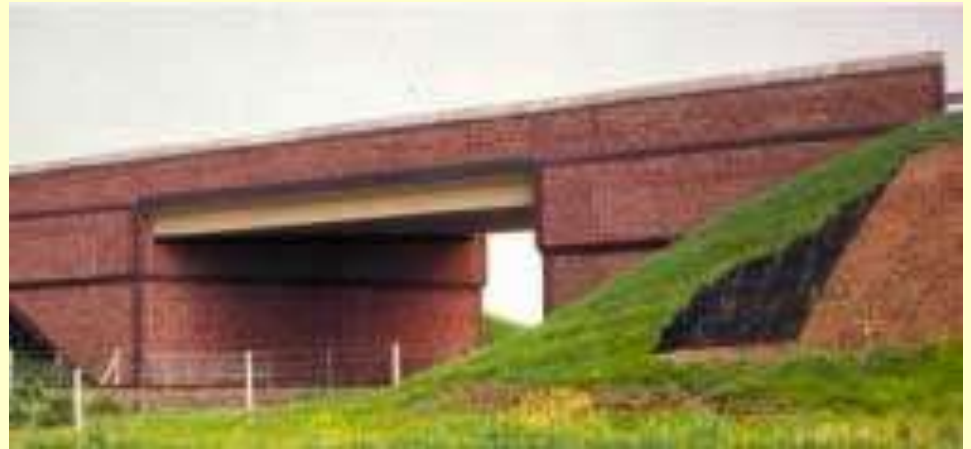
Prestressing adds **compression** to masonry. Since masonry is very **strong** in compression, prestressed masonry compensates for any external forces (**wind, earthquakes, earth pressure, etc.**) that would normally cause the wall to bow and crack from **tension** by using masonry's strength under compression.

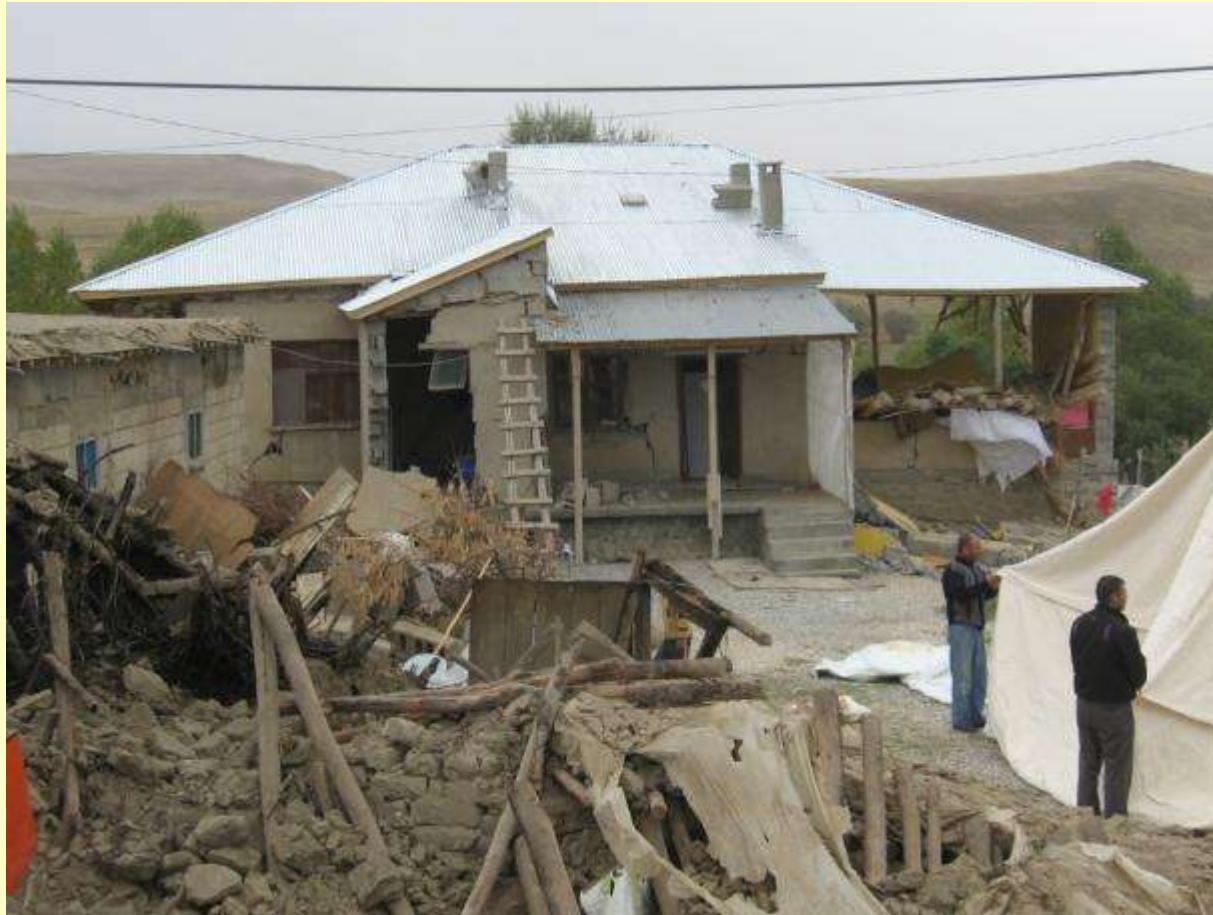
Non-engineered and traditional construction without the intervention of an engineer or an architect

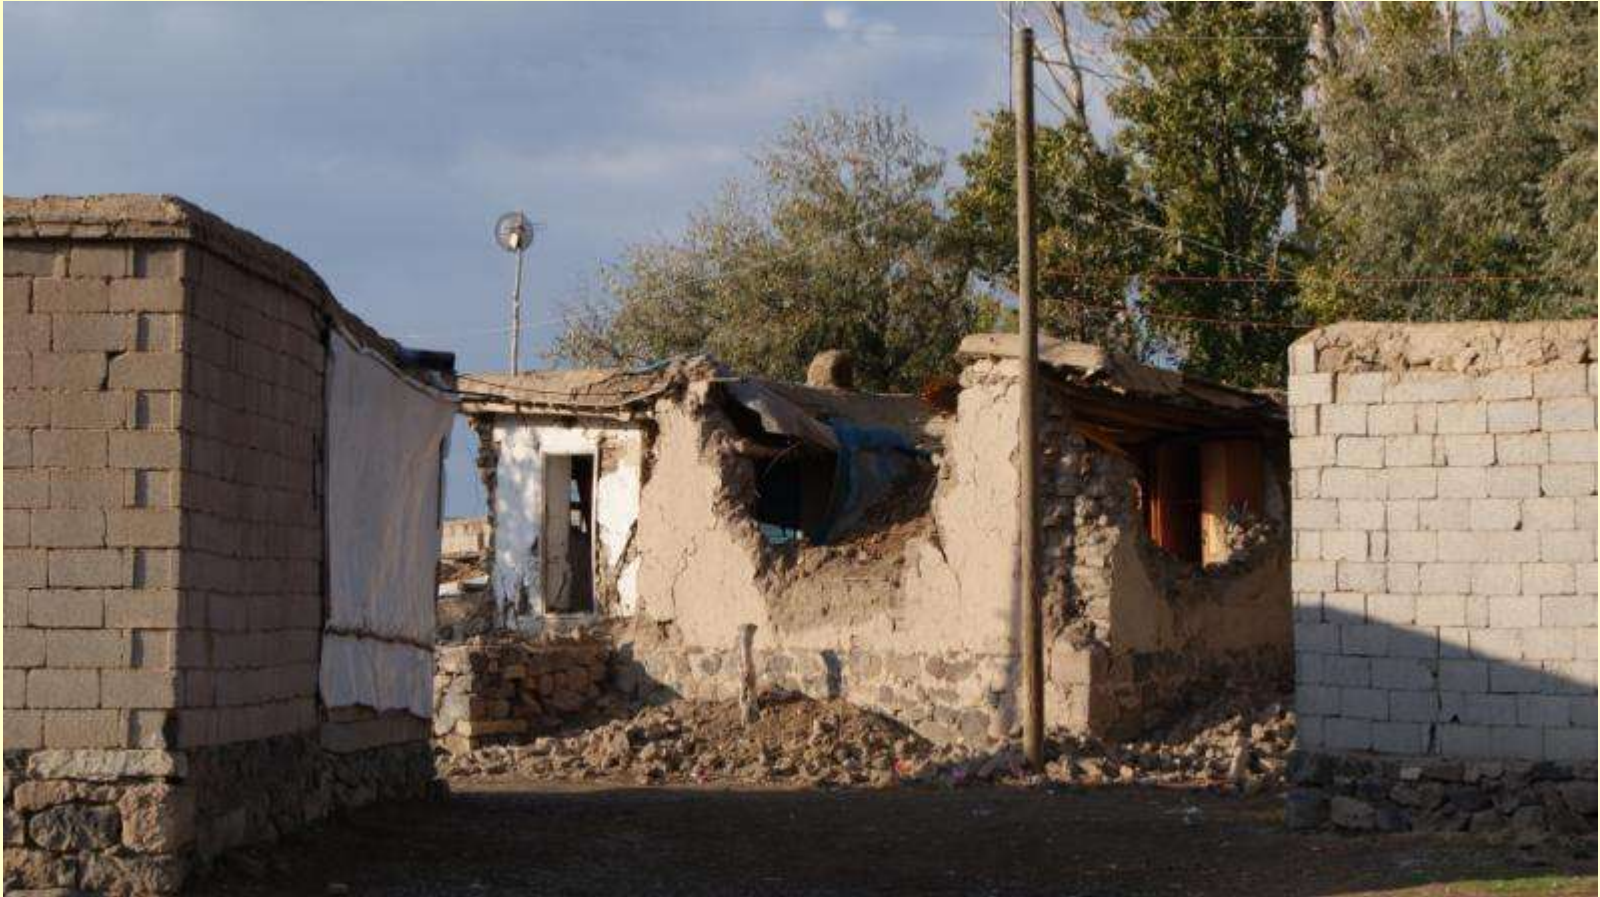
Non-engineered and traditional construction without the intervention of an engineer or an architect

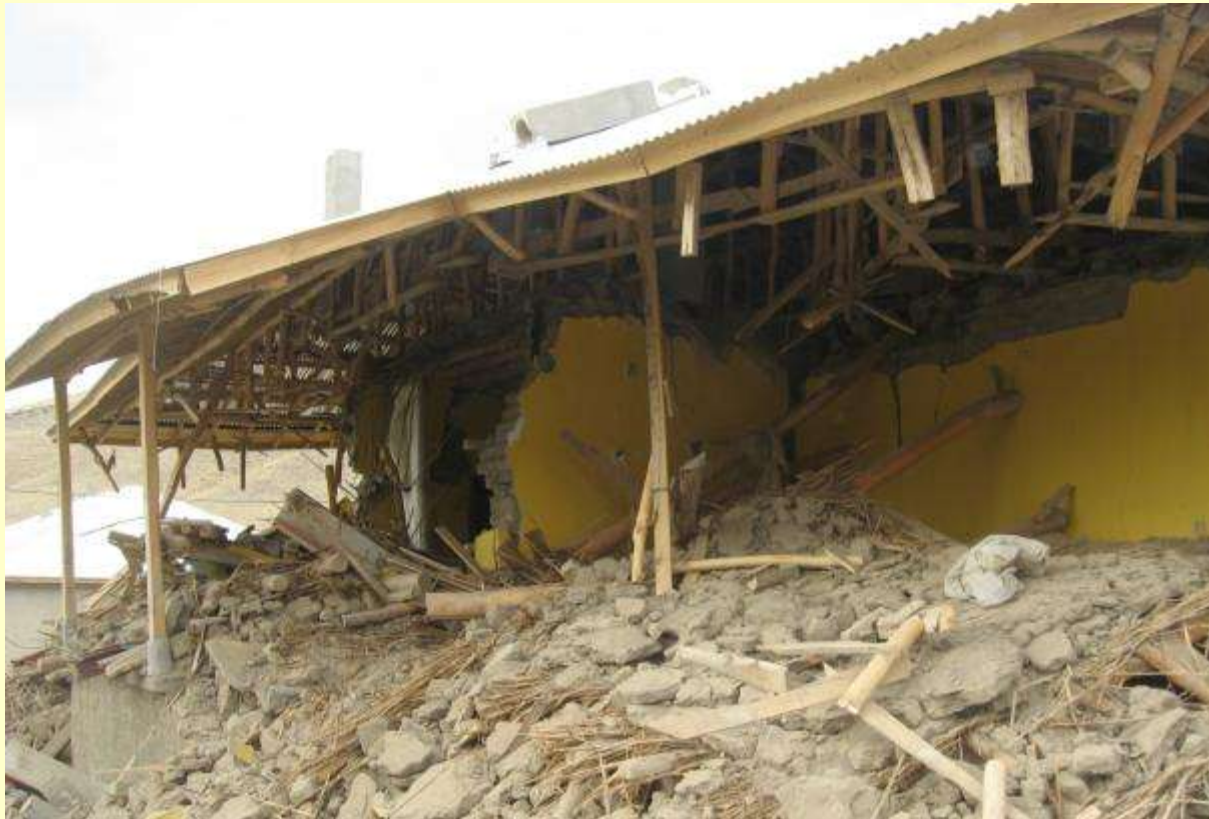
The basic rules of earthquake resistant design are ignored although masonry chapter of Turkish Earthquake Code is based on empirical approach with simple geometrical limitations and stress checks

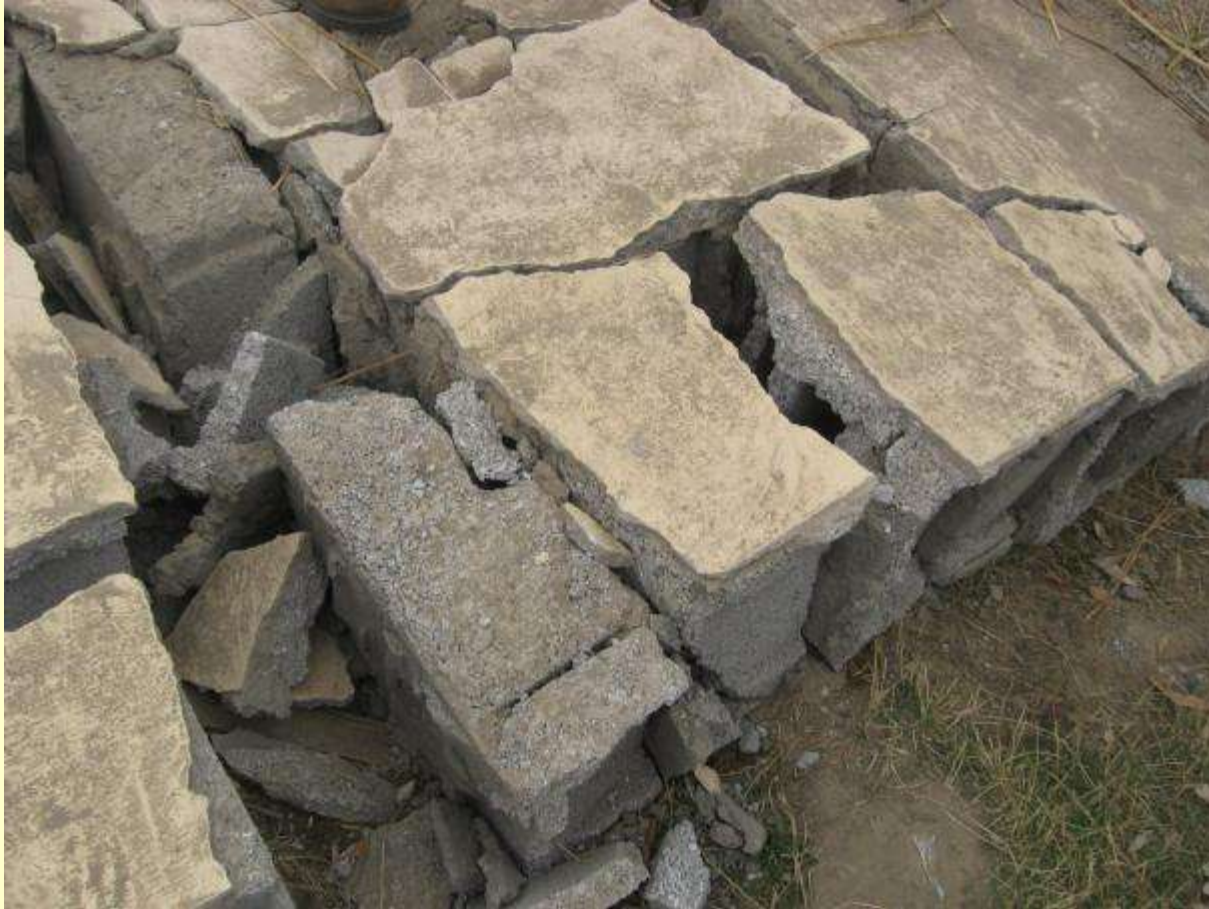
The use of low-strength masonry units (adobe, rubble stone, etc.) due to socio-economical and climate conditions of the region

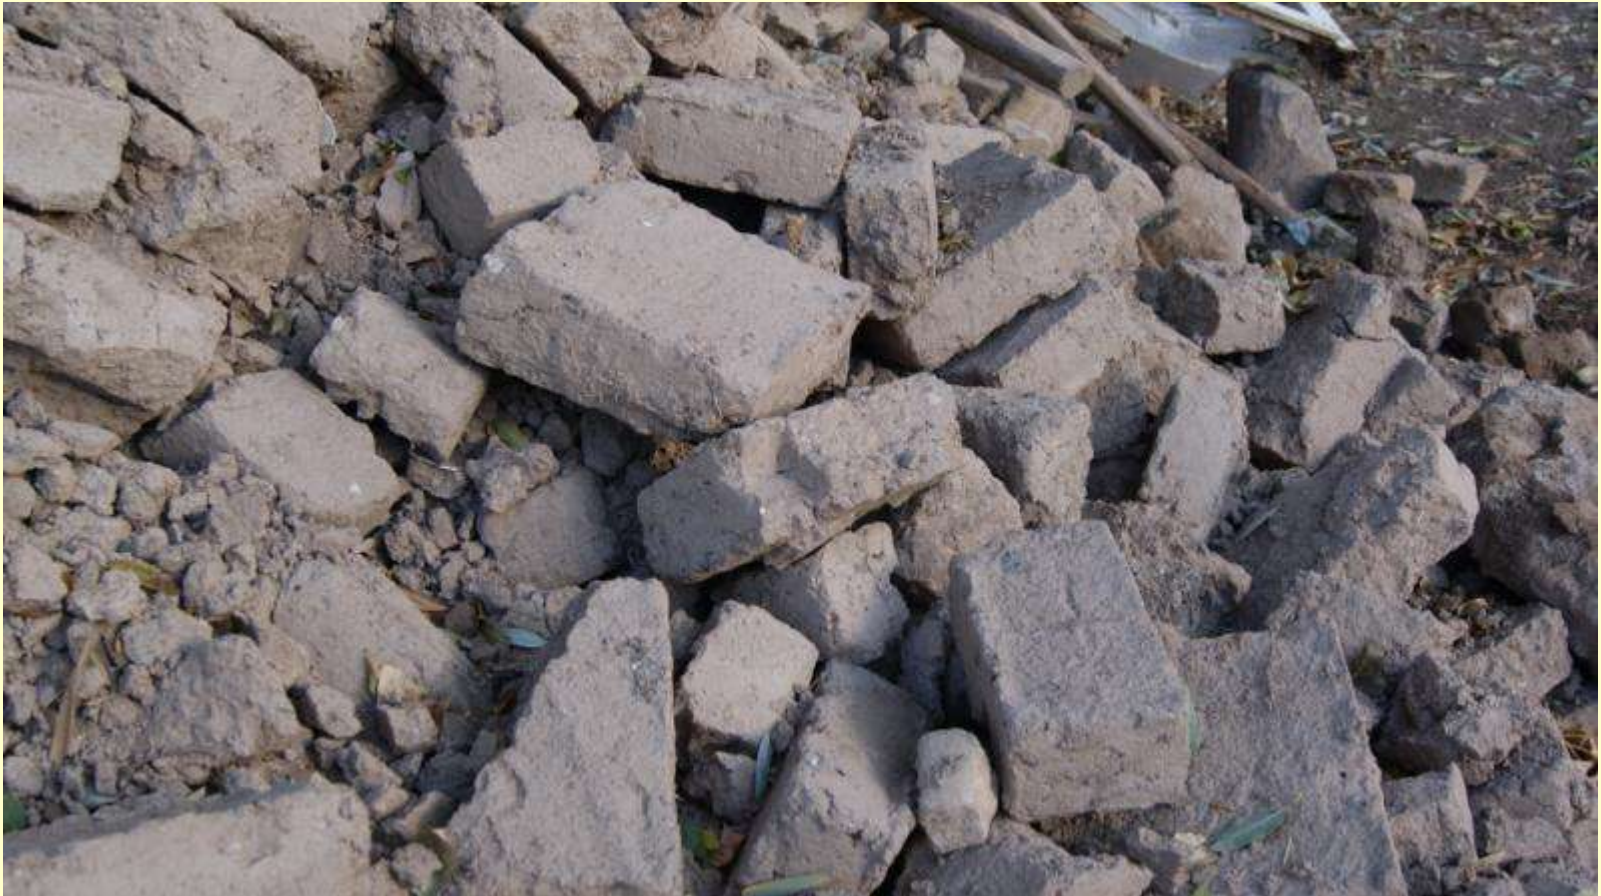
The use of low-strength masonry units (adobe, rubble stone, etc.) due to socio-economical and climate conditions of the region

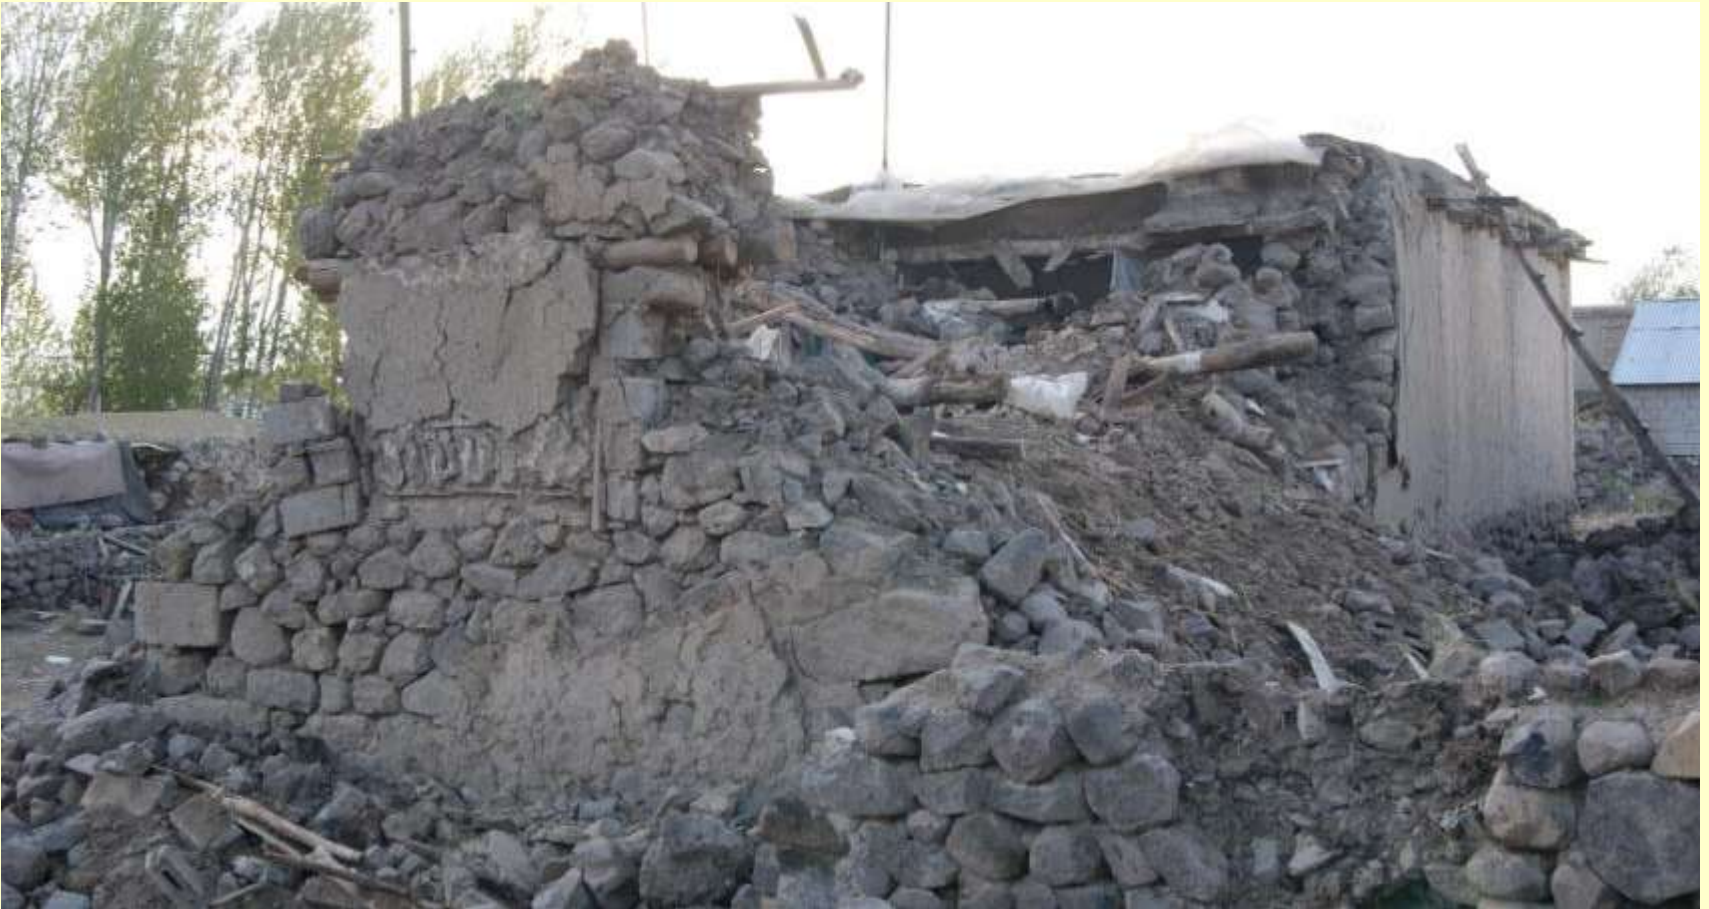
The use of low-strength masonry units (adobe, rubble stone, etc.) due to socio-economical and climate conditions of the region

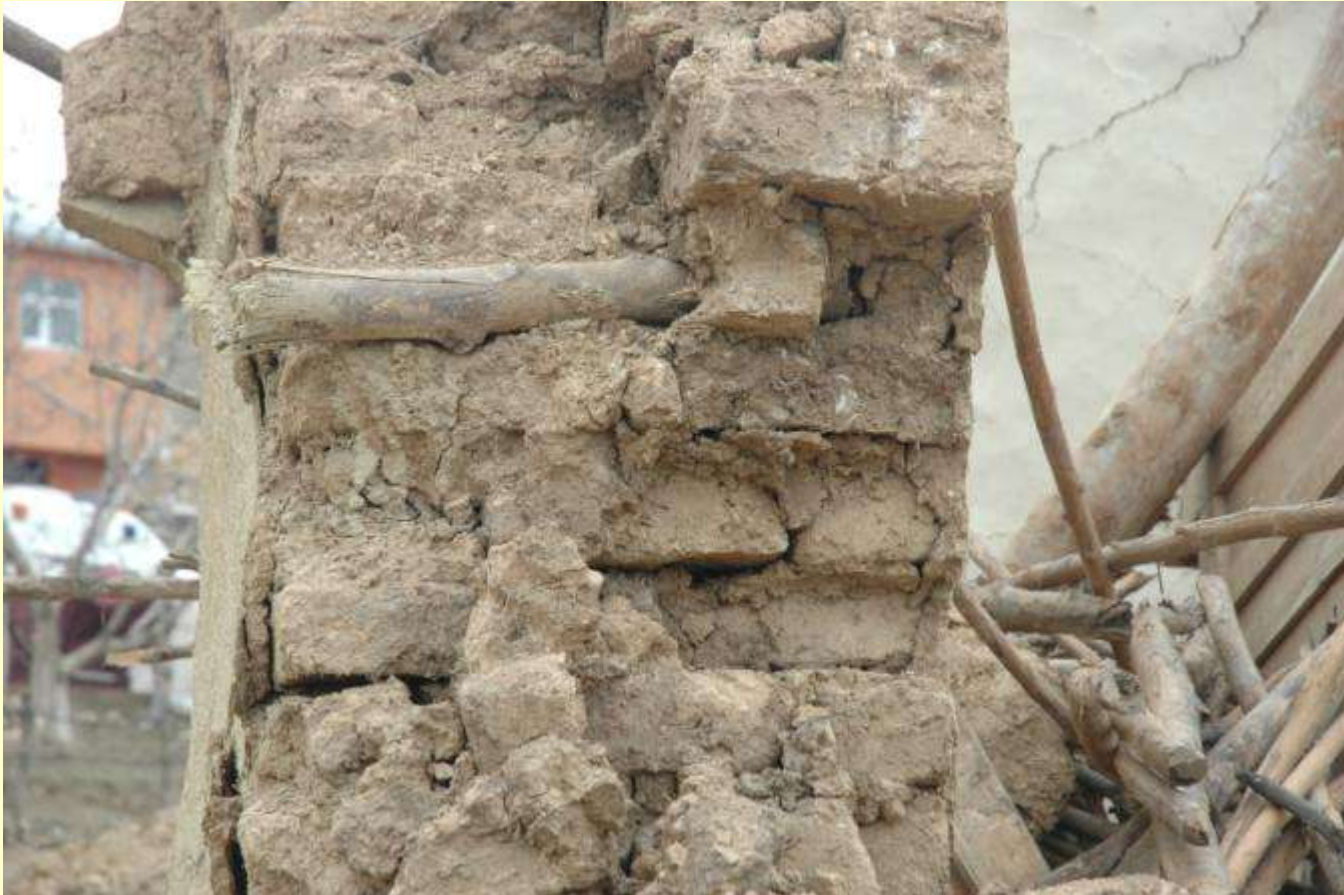
The use of mud mortar (in some cases even no mortar!) with low strength and poor bonding characteristics

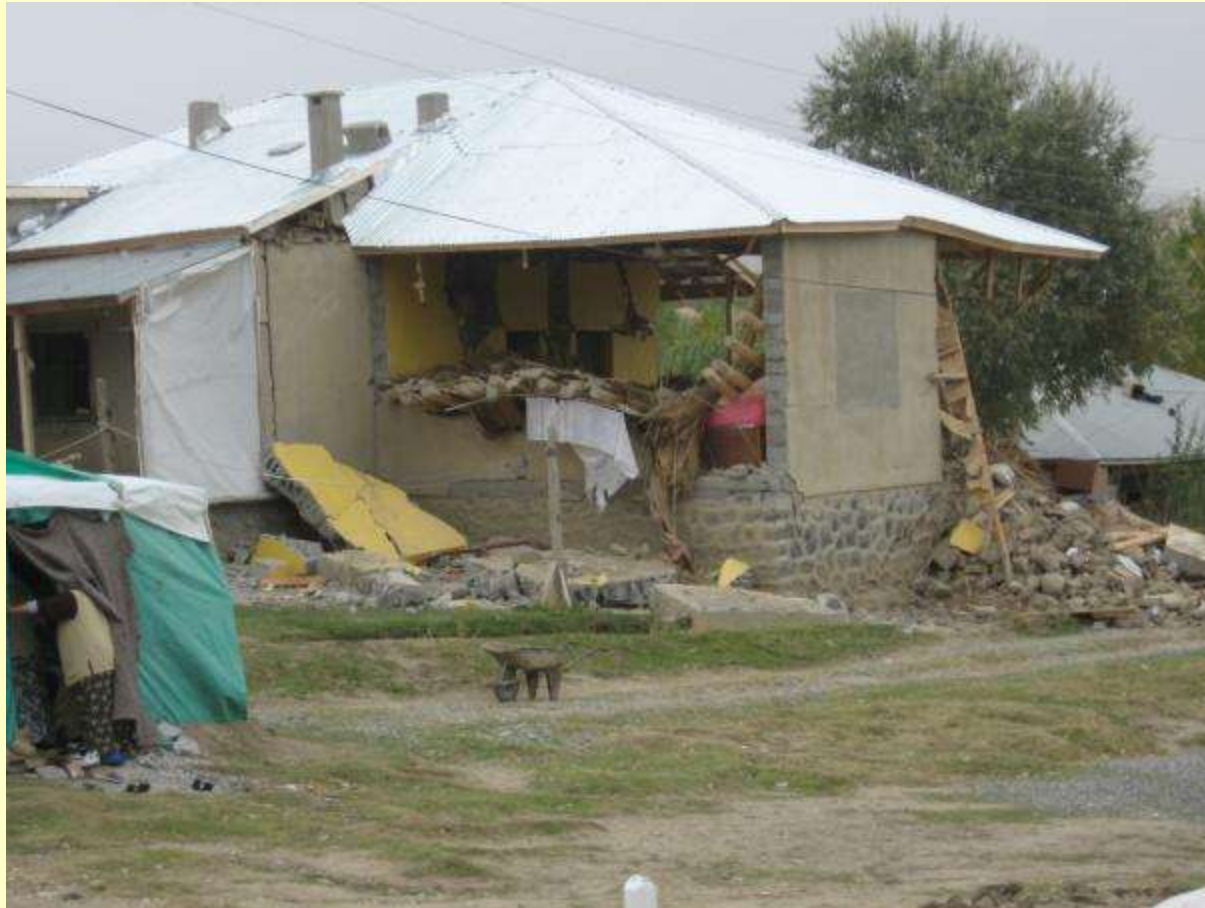
Poor wall-to-wall and wall-to-floor connections, that prevent box-like behavior of the structure.

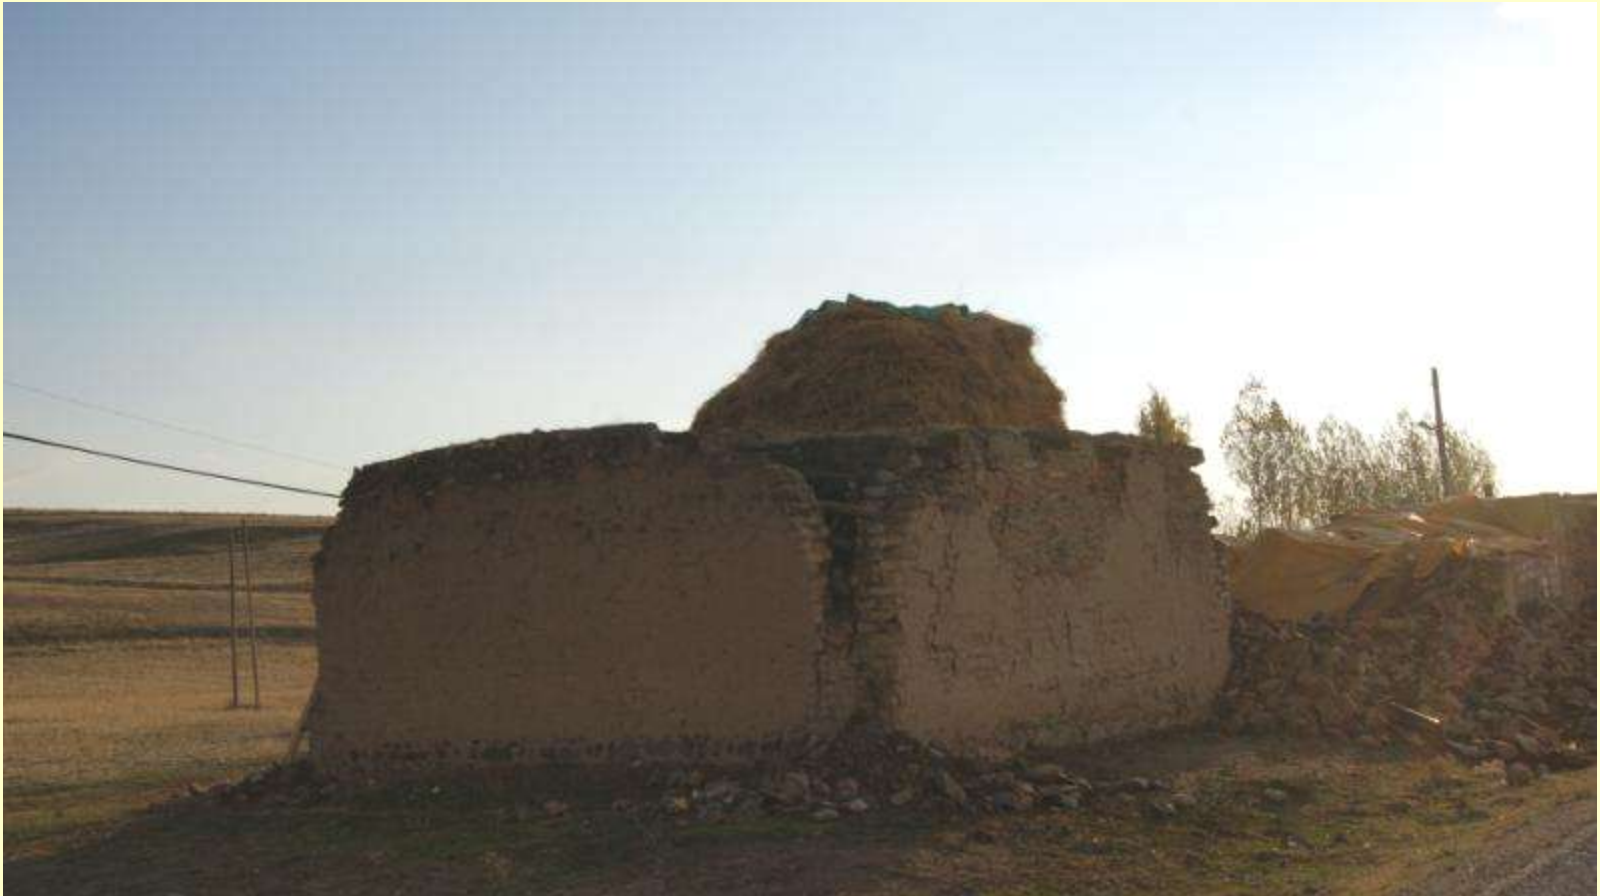
Poor wall-to-wall and wall-to-floor connections, that prevent box-like behavior of the structure.

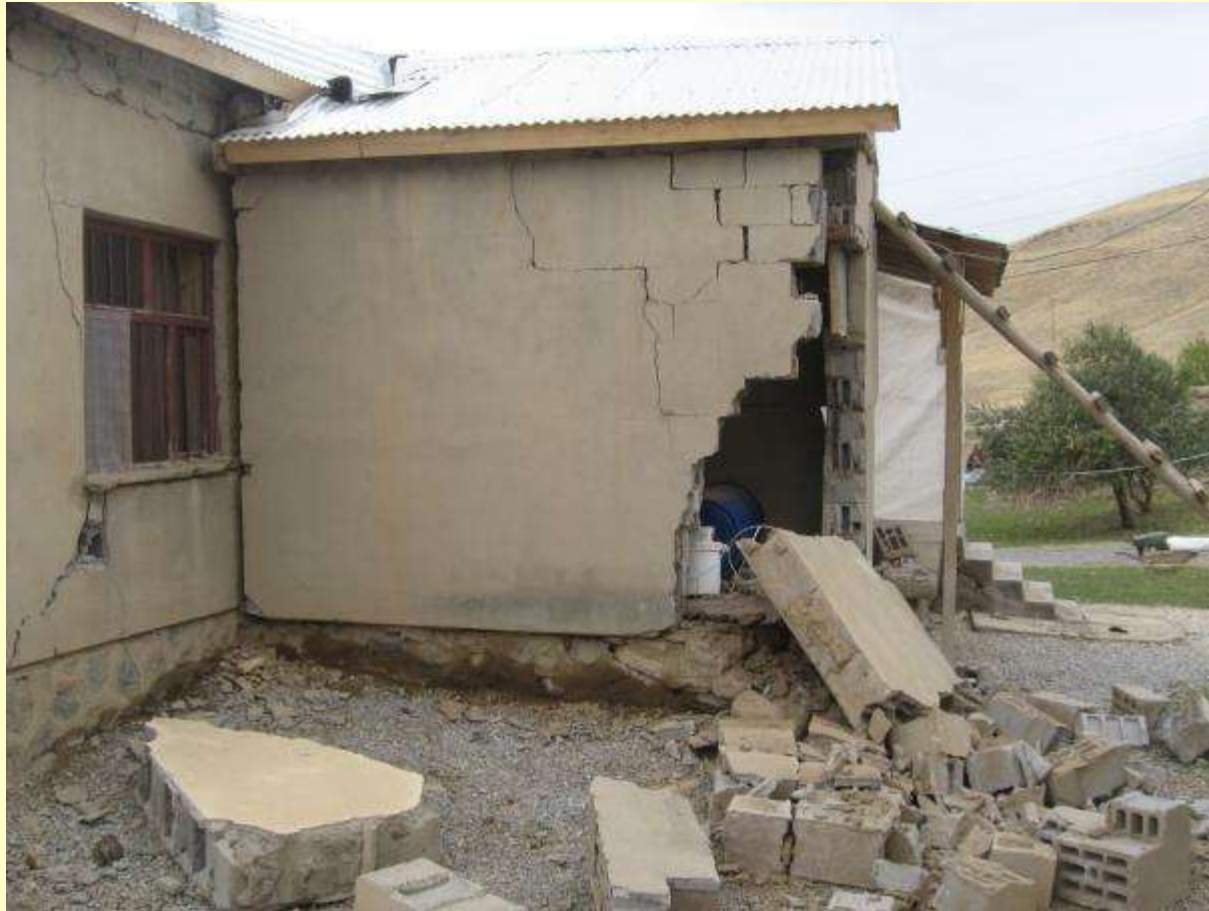
Poor wall-to-wall and wall-to-floor connections, that prevent box-like behavior of the structure.

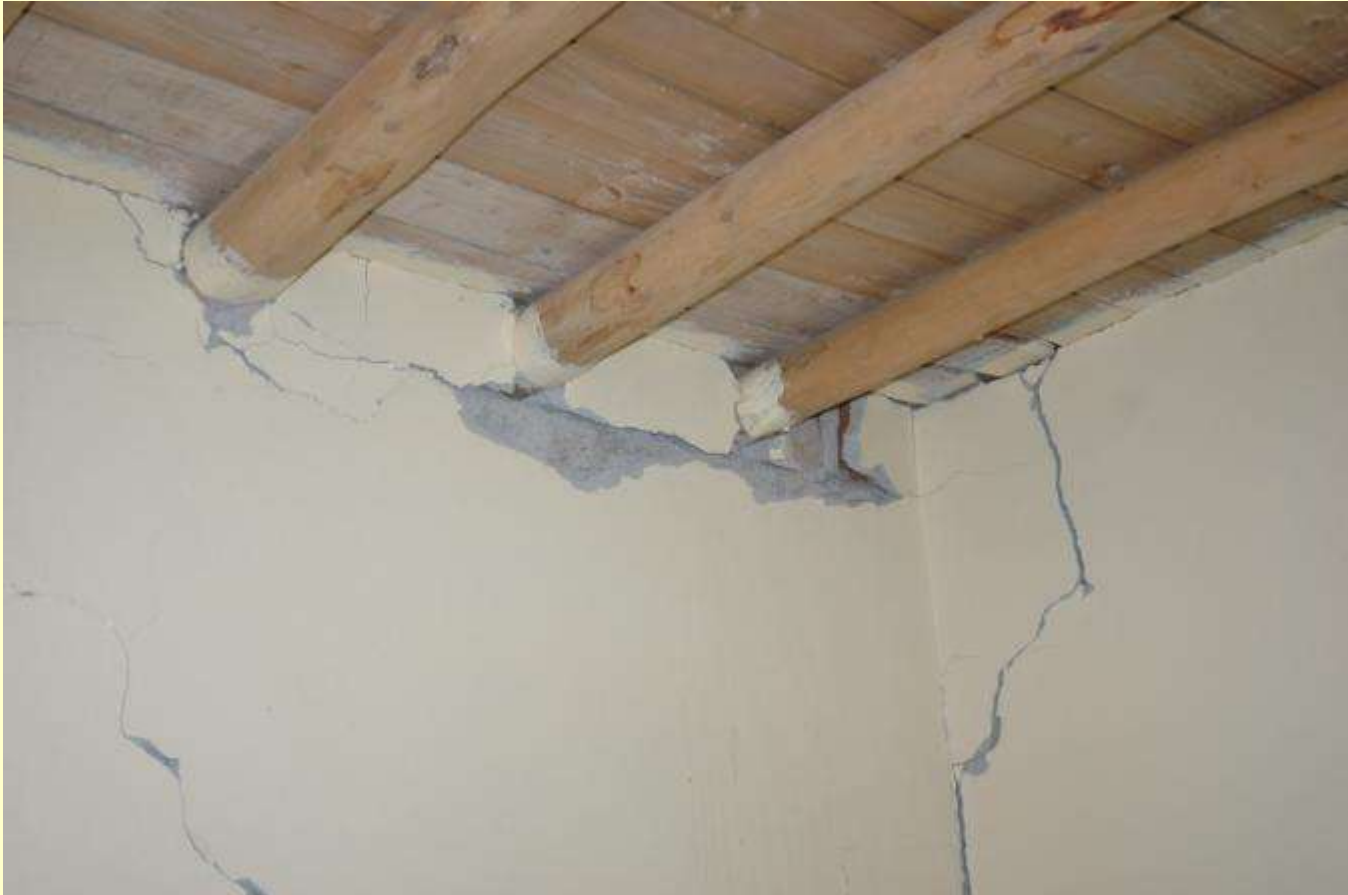
Flexible floor diaphragm, which prevents the transfer and distribution of lateral forces in a uniform manner.

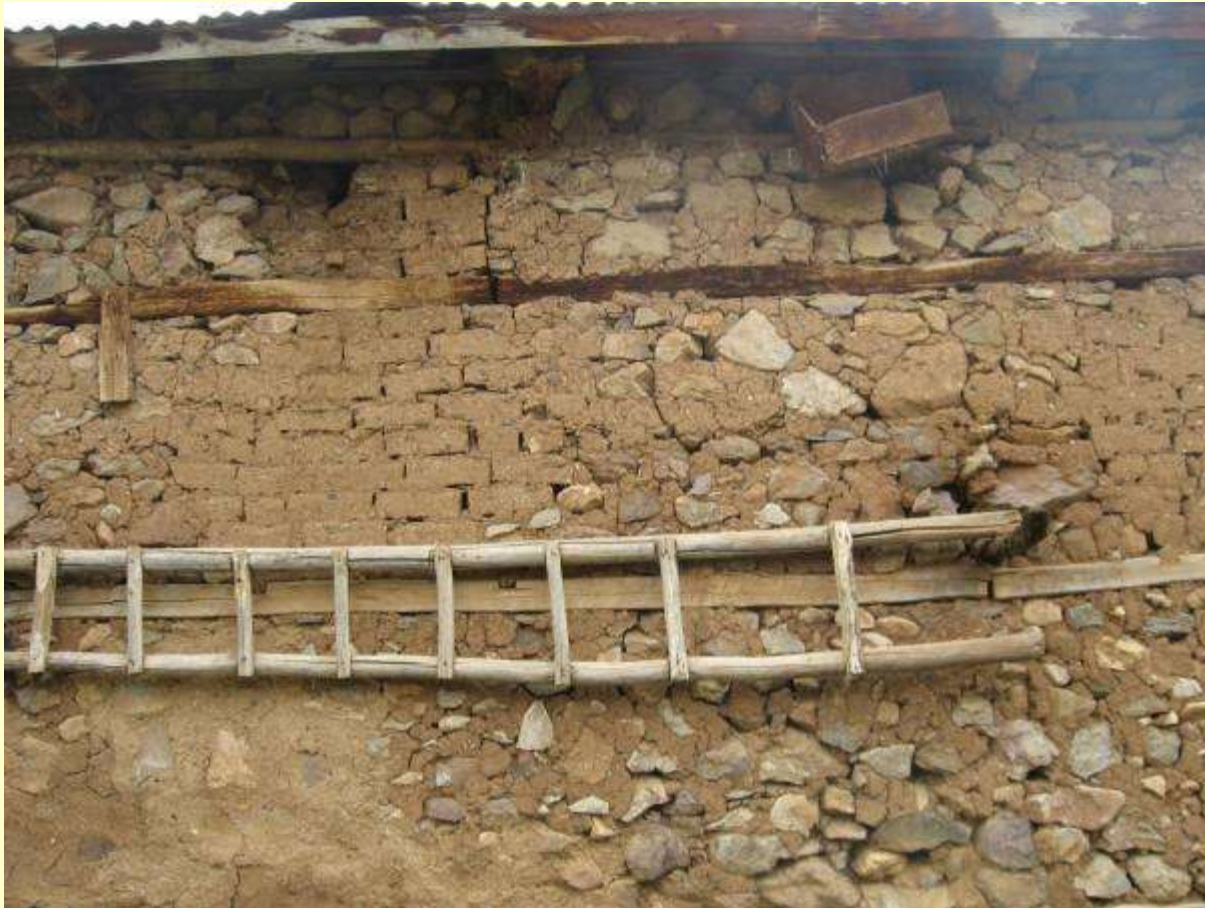
The use of different masonry wall materials in the same building, at the same floor and even at the same wall.

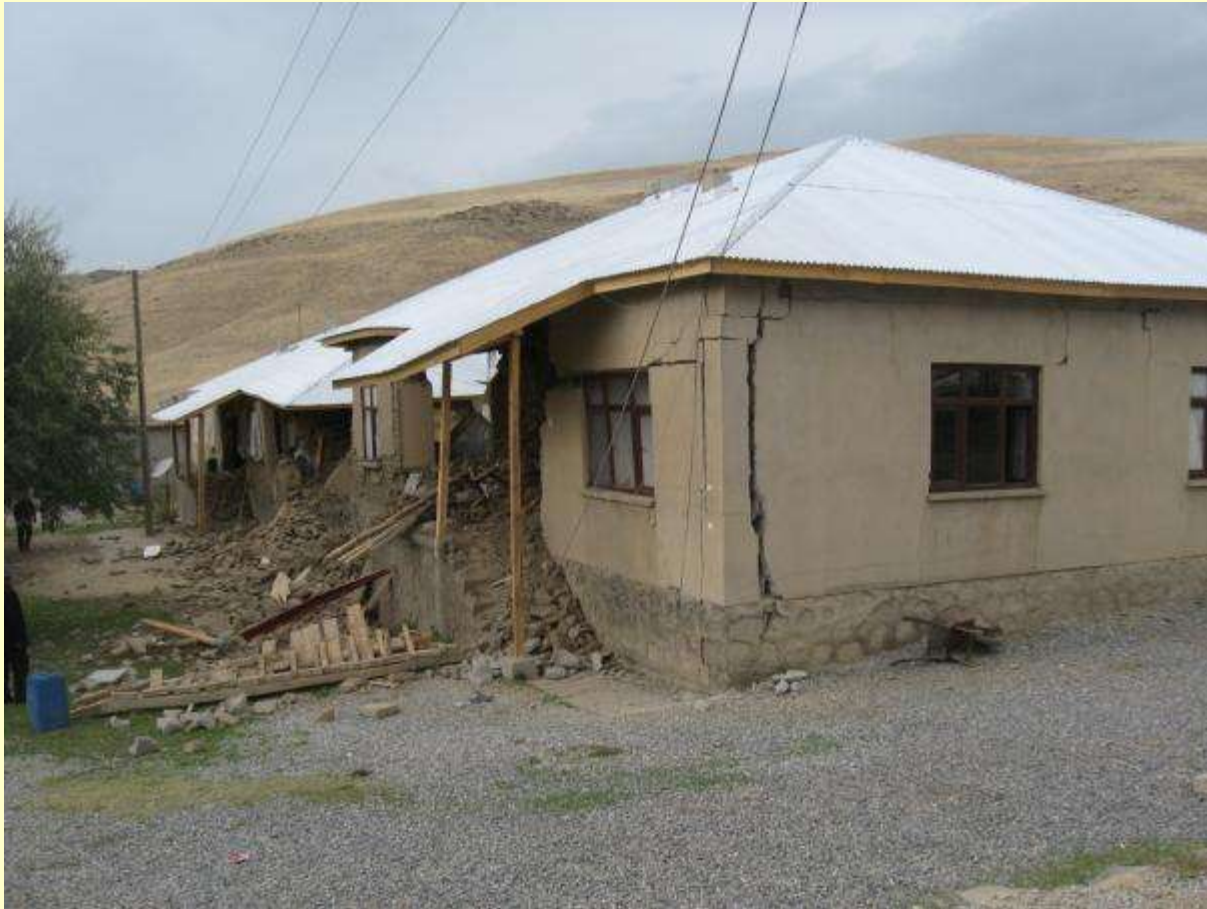
Inadequate amount of load-bearing walls, which causes high shear stresses during ground shaking.

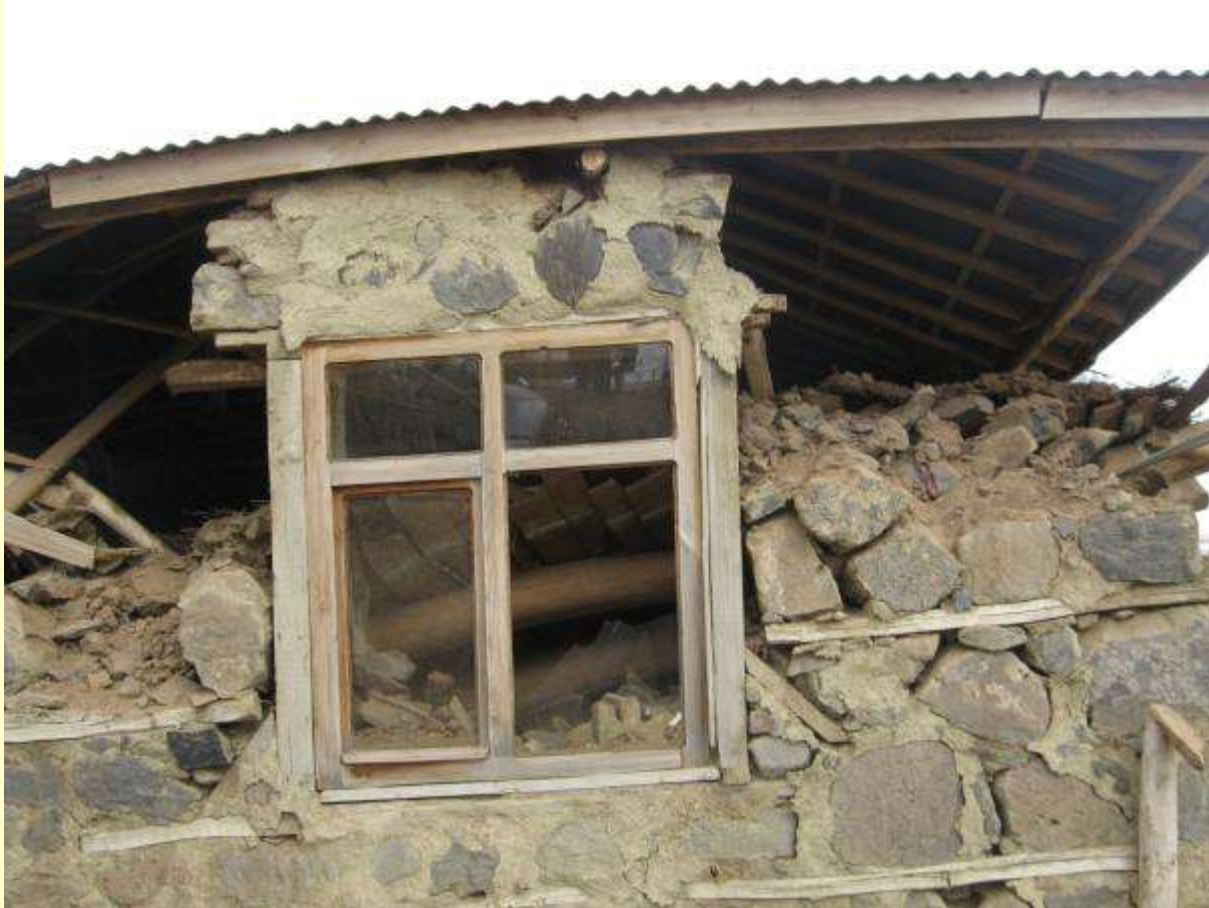
Improper placement of door and window openings in walls, which creates vulnerable and weak zones in the structure.

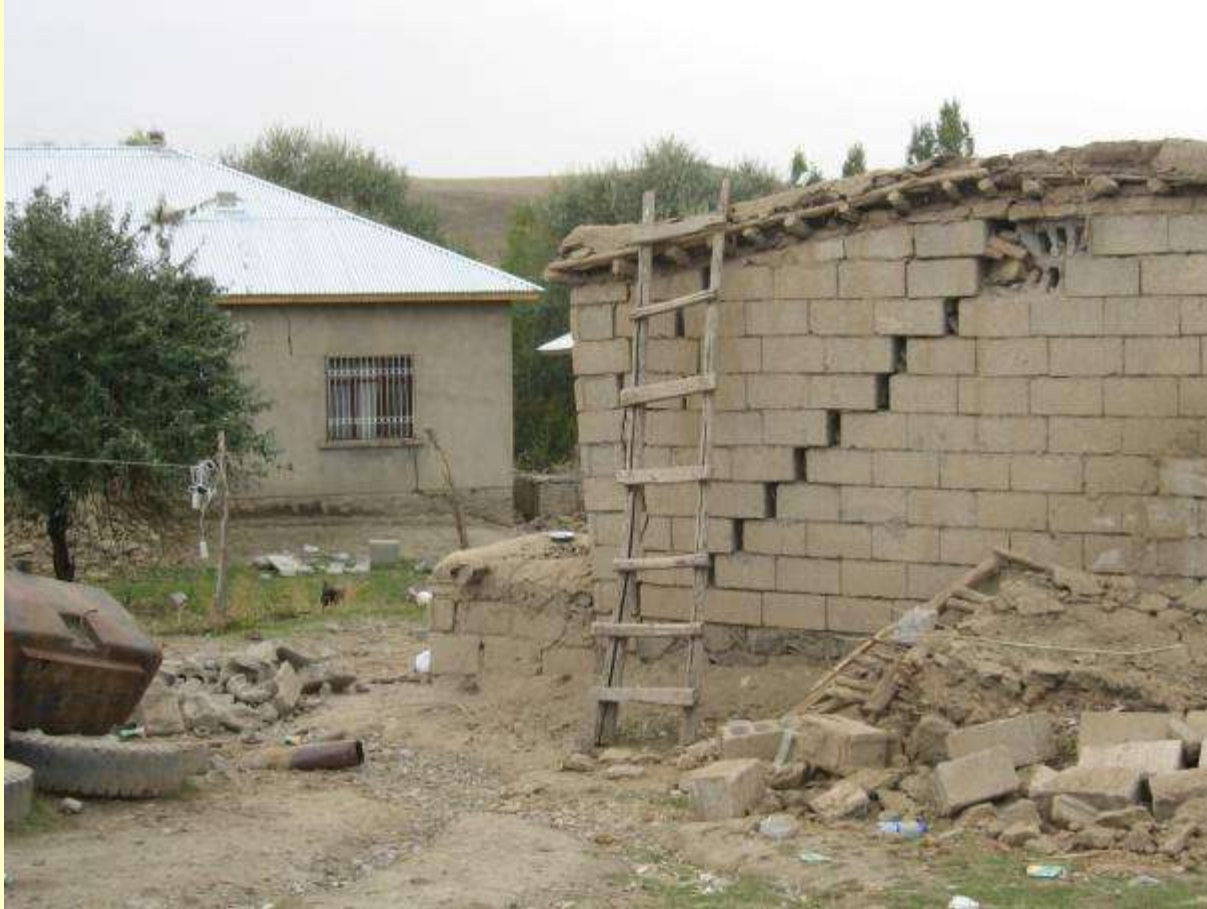
Poor workmanship, which impairs the integrity and capacity of load bearing walls, and in turn whole the structure.

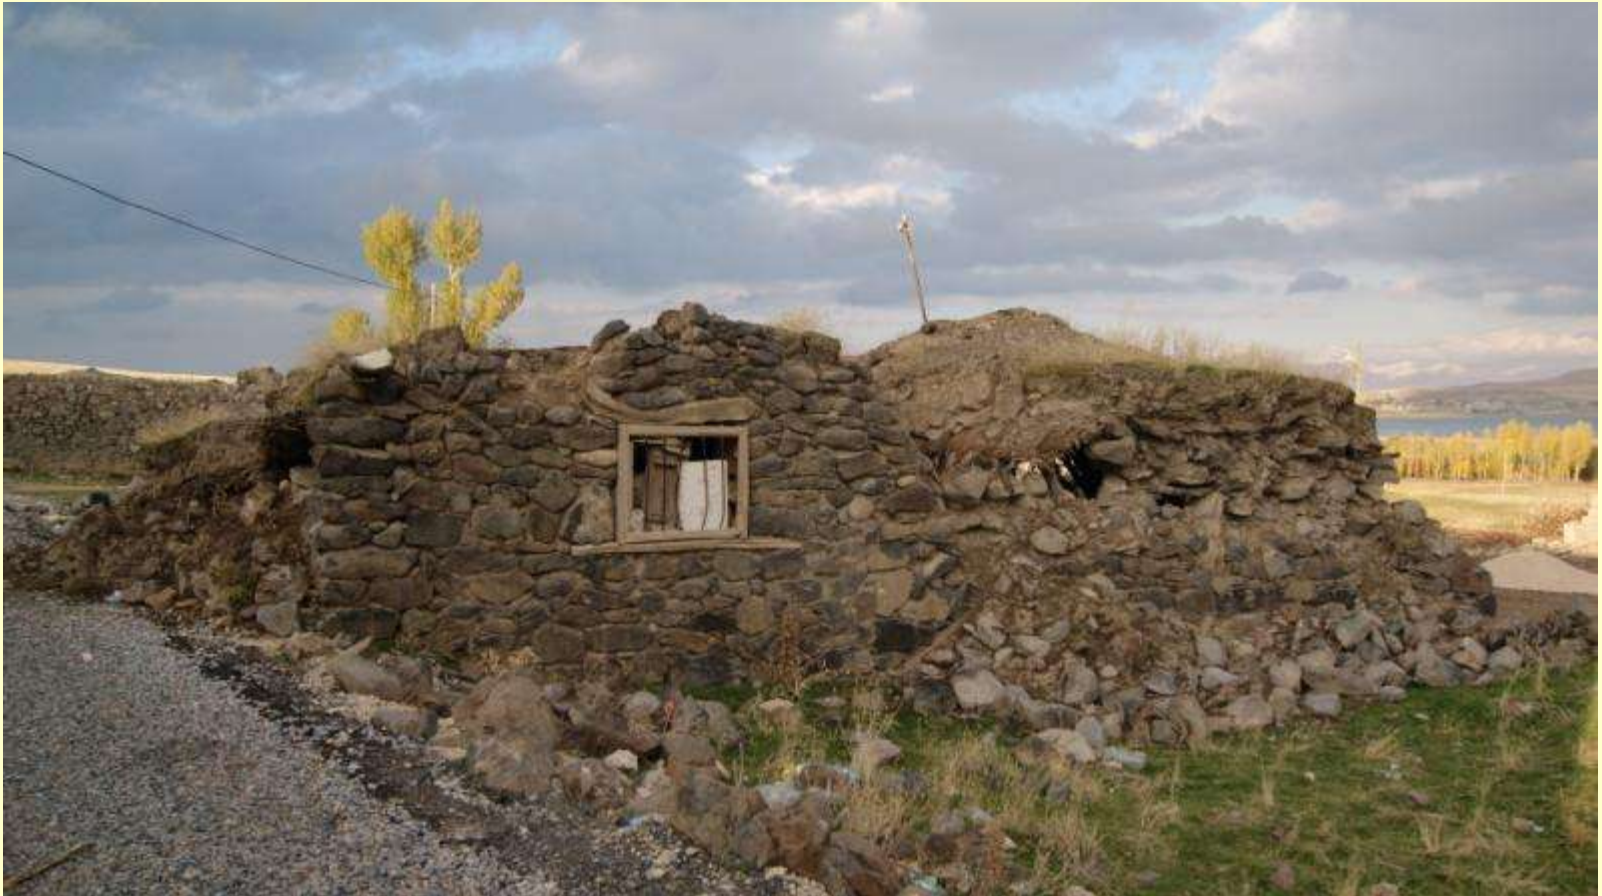
Poor workmanship, which impairs the integrity and capacity of load bearing walls, and in turn whole the structure.
