D-Learning Class for Earthquake and Tsunami Disaster Mitigation
November 10, 2017

Seismic Performance of Masonry Buildings in Turkey

Prof. Murat Altuğ Erberik

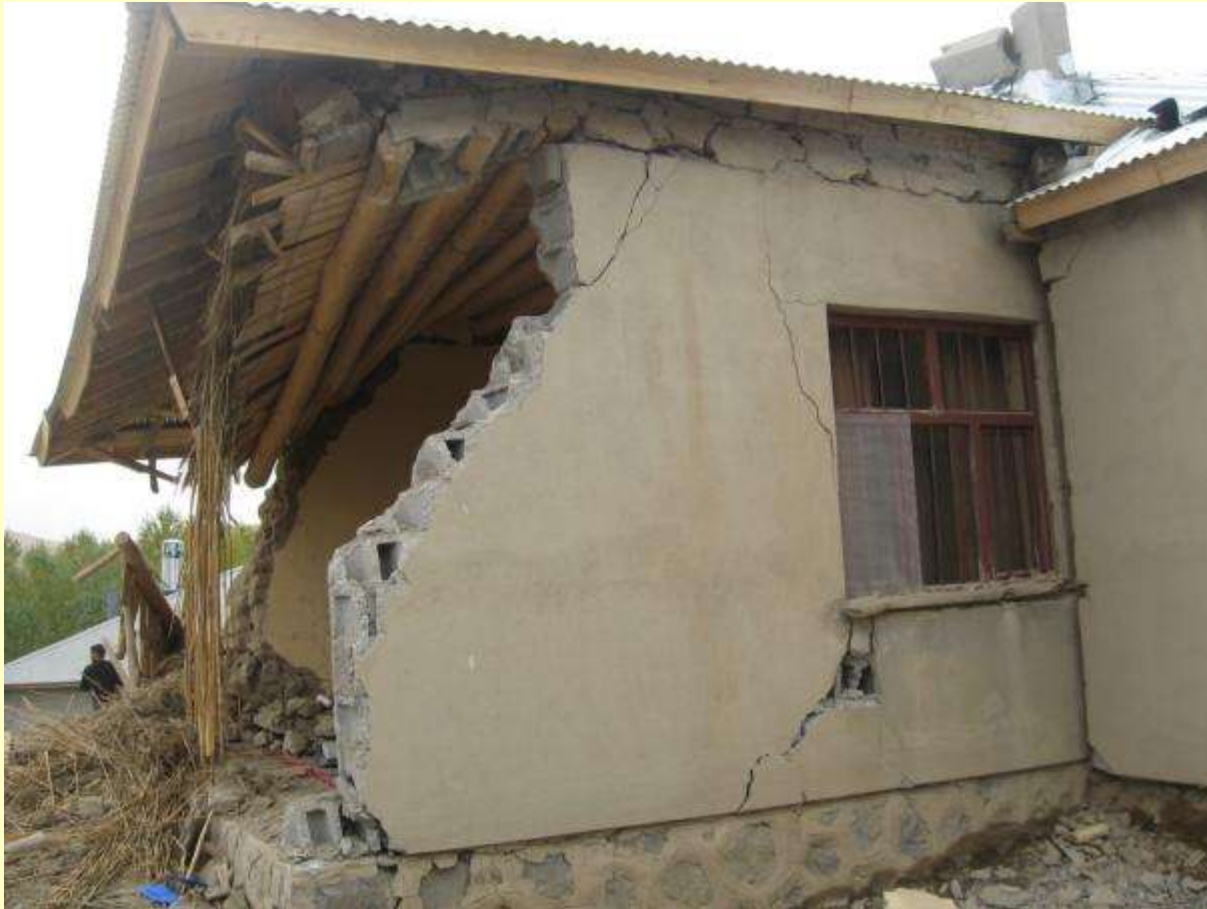
Absence of horizontal bond beams, which enables the transfer of earthquake induced loads through the walls to the foundation in a safe manner.

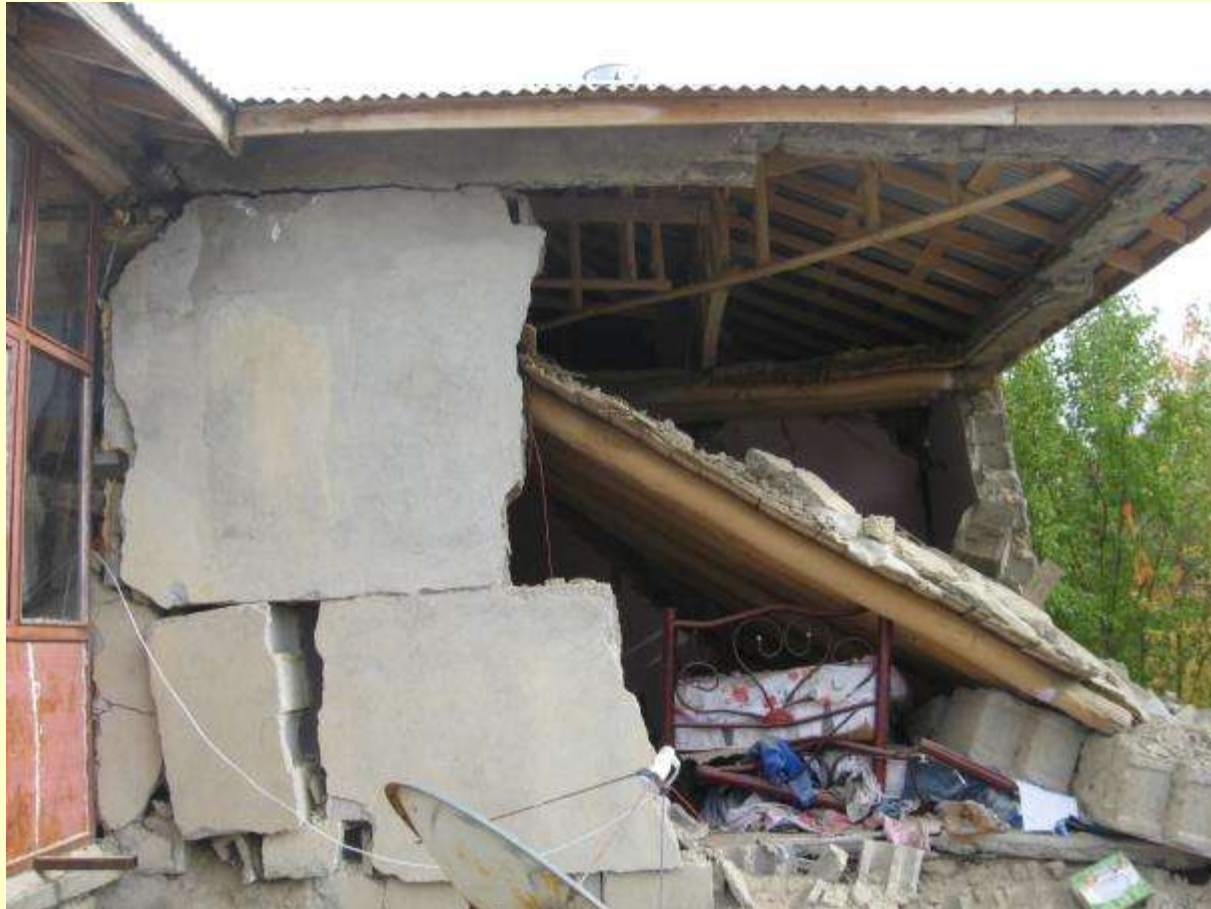
Absence of horizontal bond beams, which enables the transfer of earthquake induced loads through the walls to the foundation in a safe manner.

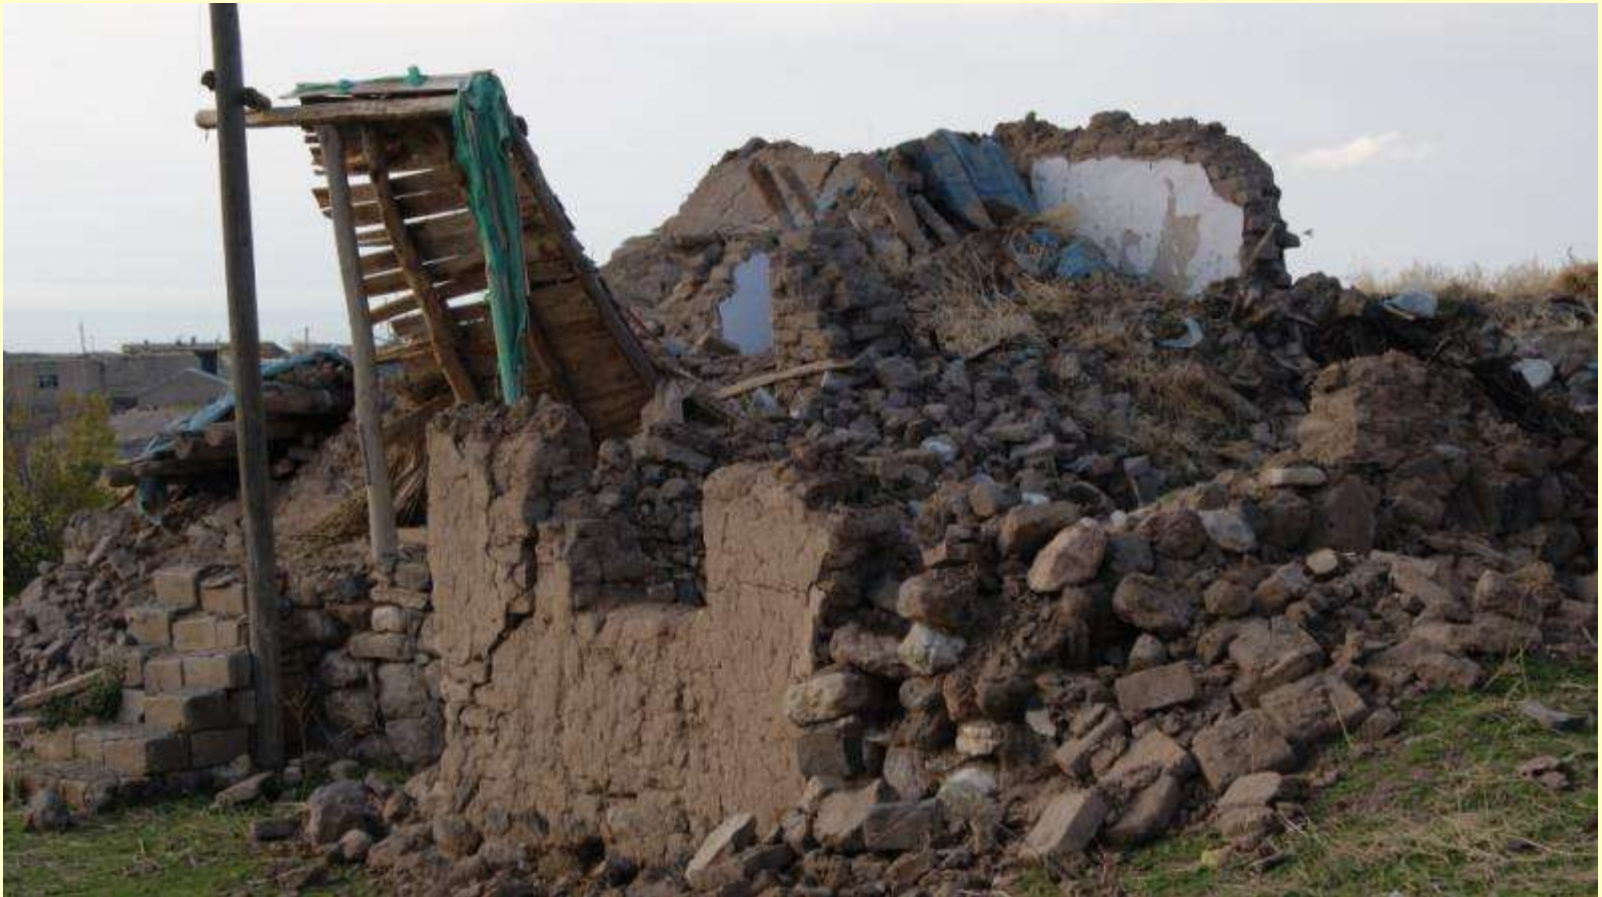
Heavy earthen roofs, which increase the death toll during ground shaking since such type of roofs collapse inwards

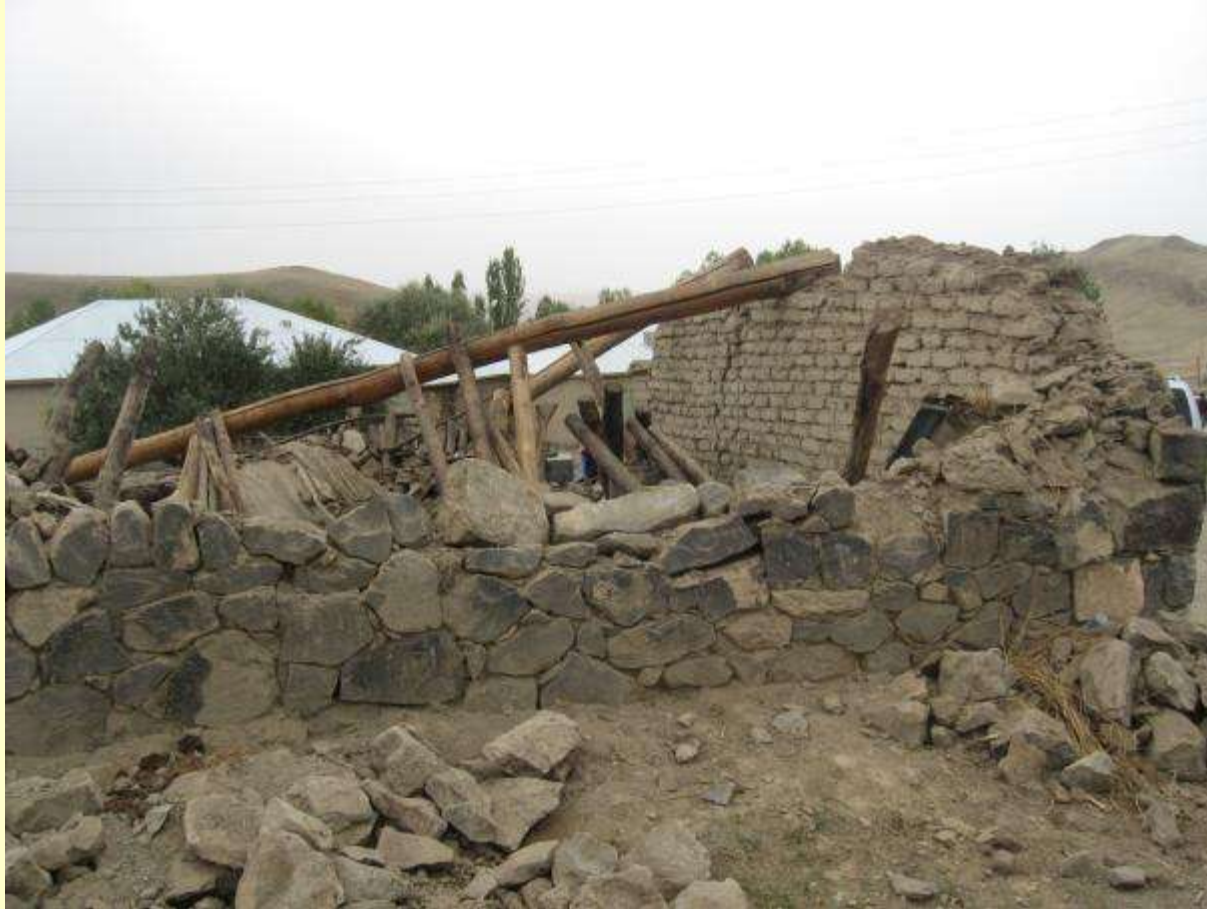
Heavy earthen roofs, which increase the death toll during ground shaking since such type of roofs collapse inwards

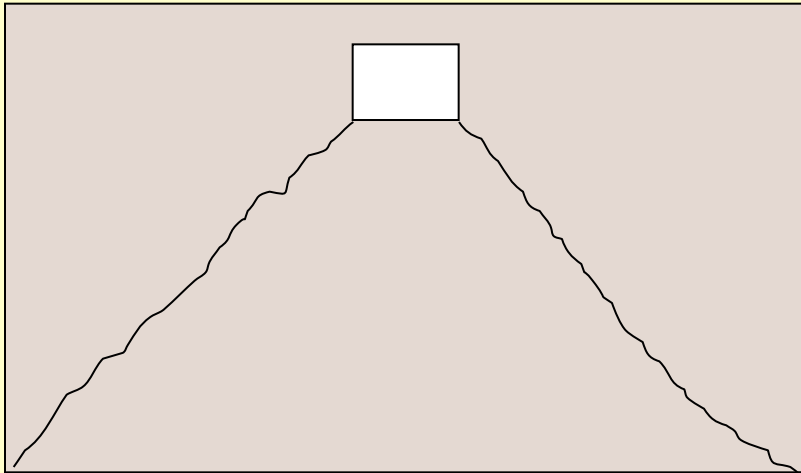
Diagonal shear cracks can follow different paths depending on the length and height of the wall, the location and size of the openings in walls.

Some examples for the influence of openings in walls on the crack pattern

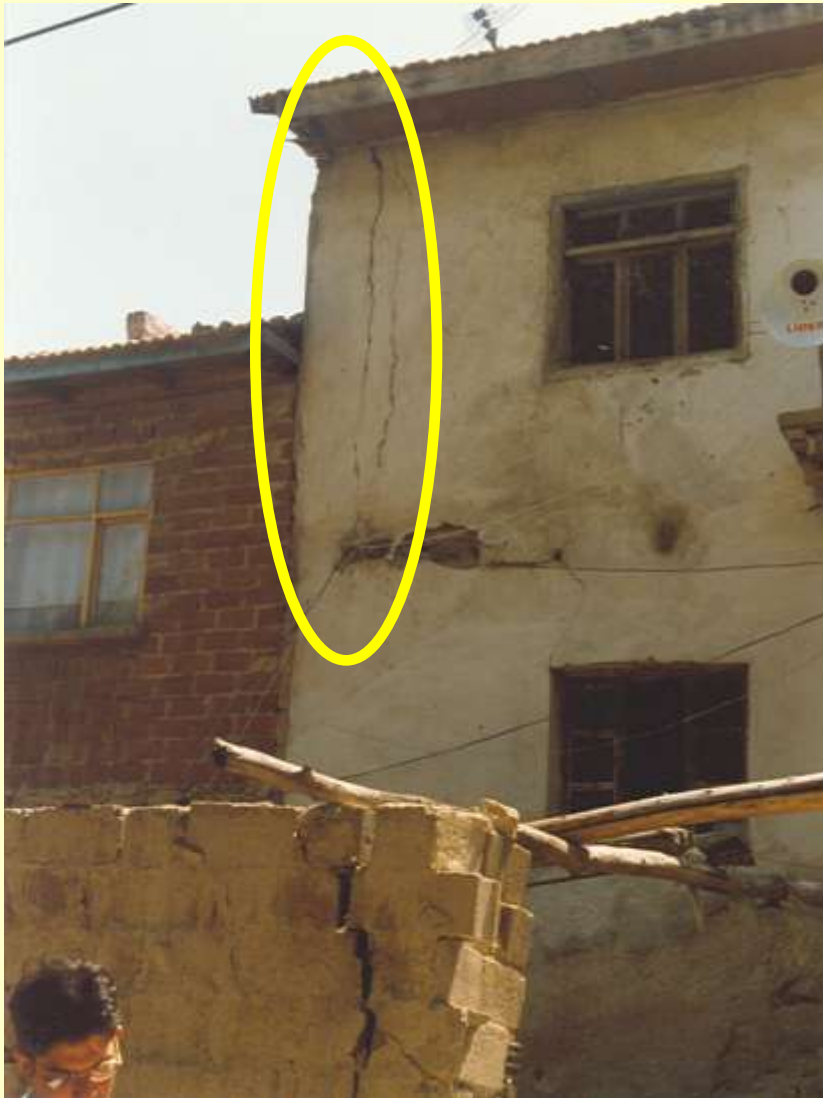
After Dinar Afyon
Earthquake (1995),

Weak Wall-Roof
Connection Plus
Hammering Effect

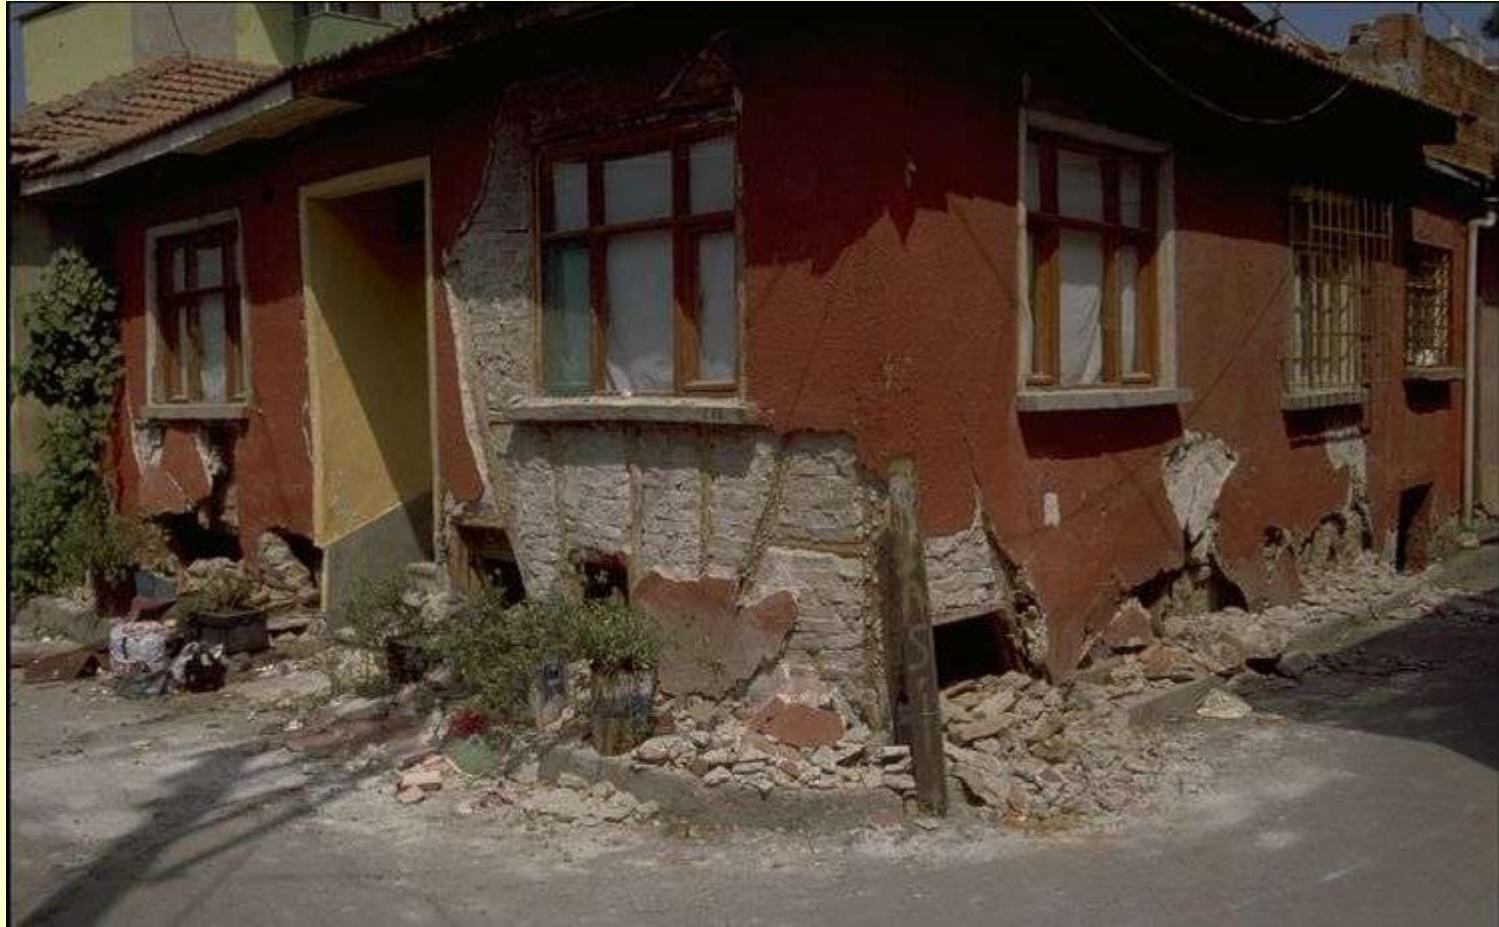
Old style masonry house, where wood reinforcement divides the masonry wall into small pockets which dissipate energy without leading to complete collapse after İzmit Earthquake (1999), $M = 7.4$.
